WILLIAMS BRIDGE DAM
PENNSYLVANIA GAS AND WATER COMPANY

PHASE I INSPECTION REPORT
NATIONAL DAM INSPECTION PROGRAM

National Dam Inspection Report. Williams Bridge Dam, Pennsylvania Gas and Water Company (NDS-ID-373), Susquehanna River Basin, Stafford Meadow Brook, Lackawanna County, Pennsylvania.
Phase I Inspection Report.

Prepared by
GANNETT FLEMING CORDDRY AND CARPENTER, INC.
Consulting Engineers

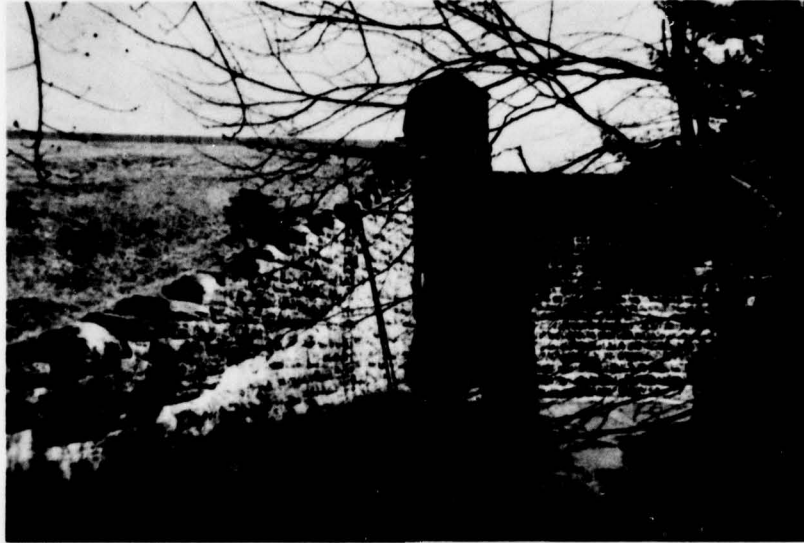
(3) On the main spillway right retaining wall, 7 of the 11 concrete caps covering the tops of the post-tensioned steel bars that were installed in the 1962 repairs are disintegrating (Photograph I). The wall appeared to have a slight tilt toward the outlet channel. Survey points were marked on the wall, and the Owner said the wall is being monitored for movement.

(3) The continued disintegration of the concrete caps over the post-tensioned steel bars on the main spillway right retaining wall could cause corrosion and potential ineffectiveness of the bars that could result in failure of this critical feature.

I. Masonry Retaining Wall Between Embankment and Outlet Channel of Main Spillway Showing Repaired Diagonal Crack and Disintegration of Concrete Caps - Wet Area Shown Behind Retaining Wall

- (4) Repair damage to embankment with construction of French drains to remove water from the wet areas. Continue to monitor the main spillway right retaining wall for possible tilting.

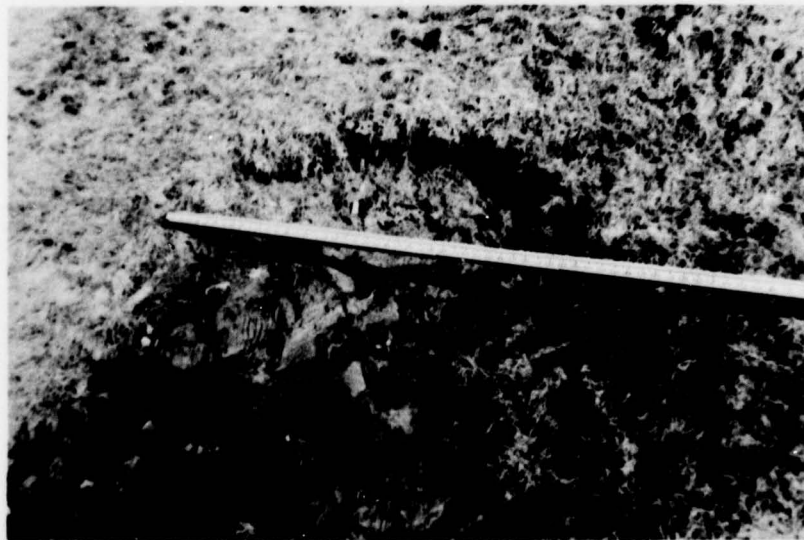
(3) The second wet area (Photographs I and J) is a 4-foot by 15-foot area located at Elevation 1340 and 12 feet right of the main spillway right retaining wall. This area is soft, saturated, and no sod is covering it. There was some clear, standing water, but no flow was exiting from the area. There has been some sloughing at the uphill side. Areas above and below were not affected. It was probed to a depth of 2 feet with a 1/2-inch diameter stick before encountering significant resistance. The underlying embankment material was examined and was found to be clay with some sand and fine gravel. The source of the water could not be determined.

(2) It is unclear whether the wet area on the embankment adjacent to the main spillway was observed on previous inspections. The Owner indicated that it is not a recent event. However, the combination of local saturation, sloughing, and the proximity of this wet area to adjacent critical features, particularly to the main spillway right retaining wall that has a history of unsatisfactory performance, is such that the wet area is of general concern.

J. Wet Area Adjacent to Main Spillway Retaining Wall
